# Honeywell Galaxy Flex/Flex+ – RS485

## Panel Connection – Ethernet Module

## DualCom Pro to Panel Wiring

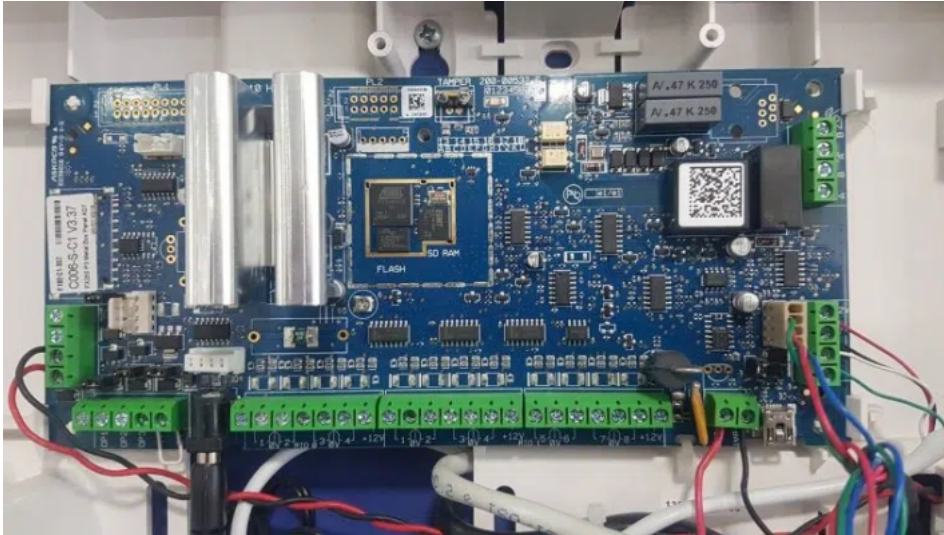
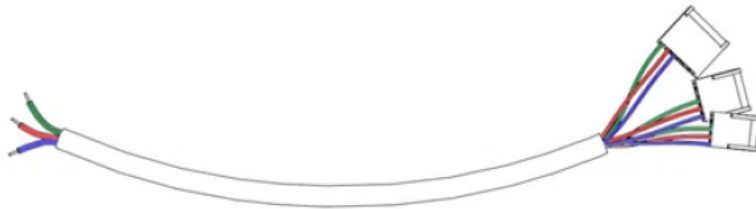
- The DualCom Pro appears as an ethernet module to the panel.
- The provided lead with the 4 pin header should be used to connect to the panel as in the picture below and the free wires connected as in the table below.

| RS485-A | Red |
| RS485-B | Blue |
| RTN | Green |
