# Texecom Premier Elite – TTL

## Panel Connection – TTL

## DualCom Pro to Panel Wiring

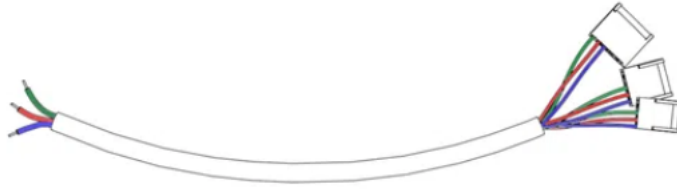
Connect the 5 pin header of the provided cable to the selected COM port on the panel and the wires to the DualCom Pro as detailed below.

Different panel models have varying numbers of COM ports and in different positions on the board. Please refer to the manufacturer's documentation to locate the appropriate COM port.

| RTN | Green Wire |
| TTL-R | Blue Wire |
| TTL-T | Red Wire |

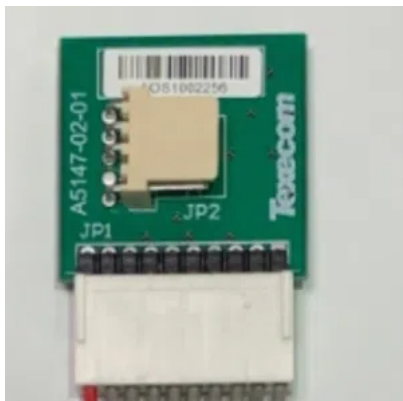
These can be ordered from distributors (Part Code JAL-001) and provide a 3rd COM port for when the first two are being used by Texecom's SmartCom module.

Ensure the adapter is correctly installed with pin 1 matching on both the adapter and the control panel (this is normally signified by the red stripe on the ribbon cable).
