DualCom Pro Panel Guide

Texecom Premier Elite

Panel Connection – TTL

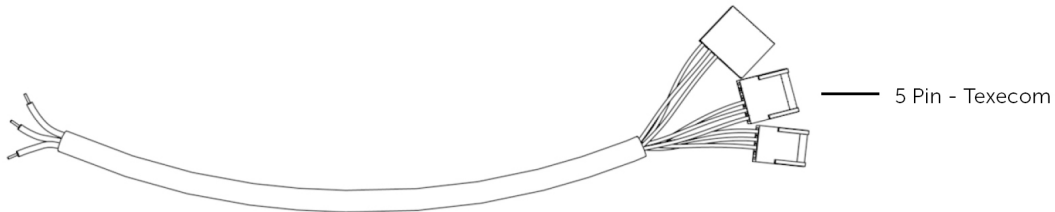
Cable Connection

MANUFACTURER	PANEL	CONNECTION	CABLE/PLUG ON	SUPPLIED CABLES
Texecom	Premier/Elite	TTL	5 Pin (cable provided)	Green - RTN Blue - TTL-R Red - TTL-T
