DualCom Pro Panel Guide

Texecom Premier Elite

Panel Connection – TTL

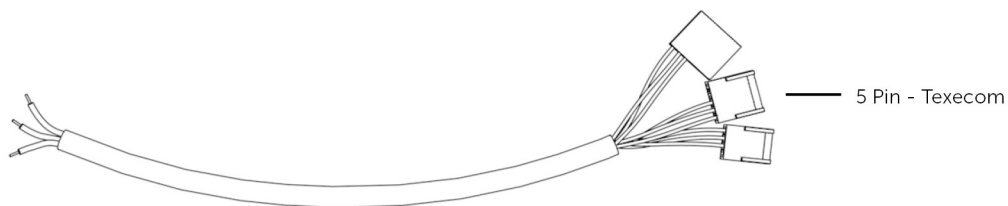
MANUFACTURER	PANEL	CONNECTION	CABLE/PLUG ON	SUPPLIED CABLES
Texecom	Premier/Elite	TTL	5 Pin (cable provided)	Green - RTN Blue - TTL-R Red - TTL-T
