DualCom Pro Panel Guide

Texecom Premier Elite

Panel Connection – TTL

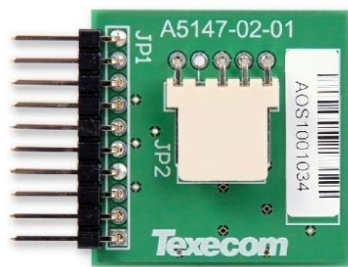
MANUFACTURER	PANEL	CONNECTION	CABLE/PLUG ON	SUPPLIED CABLES
Texecom	Premier/Elite	TTL	5 Pin (cable provided)	Green - RTN Blue - TTL-R Red - TTL-T

COM Port+ Adapter: JAL-0001
